# MEASUREMENT AND VERIFICATION (M&V) PLAN

# LAMB FARM'S BIOLOGICAL SCRUBBER SYSTEM

Agreement # - 51066

September 29, 2015

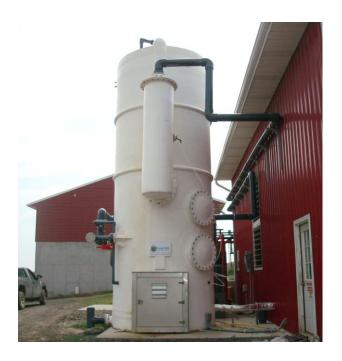
Figure 1. Photos of System Components

Biogas from digester to scrubber (bottom pipe), and biogas return from scrubber / supply to engine (top pipe).

Energy Cube biological scrubber tower.

Scrubber control panel (left), INCA 4003 gas analyzer and sampling solenoids (top right), and feedwater tubing and flow meter (bottom right)

Media on which bacteria grow, located in upper portion of scrubber.

Figure 1, includes photographs of the biological scrubber system, Figure 2, shows a diagram of the biological scrubber system, and Figure 3 schematically shows the digester system with the addition of the new scrubber and new monitored data points.

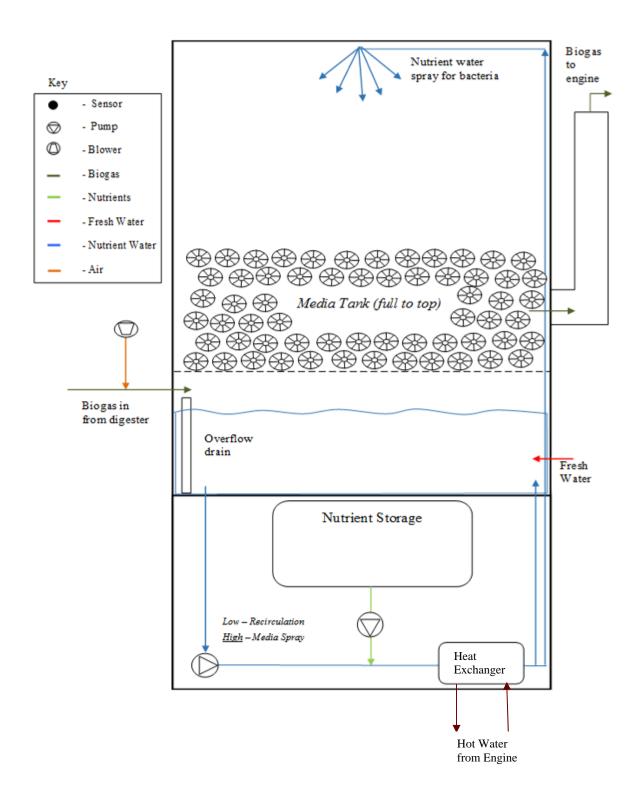
Figure 2. Schematic of Scrubber

The scrubber vessel is an eight (8) foot diameter, twenty-five (25) foot tall tank located adjacent to the existing engine / generator building. The lower five (5) feet of the scrubber vessel contains a compartment that houses all of the systems pumps, blowers, heater, and 275 gallon nutrient tank. The upper portion of the scrubber contains the media on which the bacteria grows, which is separated from the 750 gallons of water stored in the bottom of the media section by a perforated floor.

scrubber vessel has two modes of operation; low and high. When running in low the pump circulates and heats the water and nutrient mixture in the bottom of the media section. Once an hour the pump runs in high mode, which pumps water to the top of the digester vessel and sprays it down over the media to keep the bacteria moist and provide nutrients. Nutrients are fed into fresh water as it is pumped into the the scrubber vessel.

Biogas flows into the water storage portion of the upper media section of the scrubber, just above the water line. It then flows up thru the media, and out the opposite side of the scrubber and thru the mist eliminator on the side of the scrubber. This helps remove some of the moisture introduced to the biogas in the scrubber, before it reaches the existing cooling and de-watering heat exchanger.

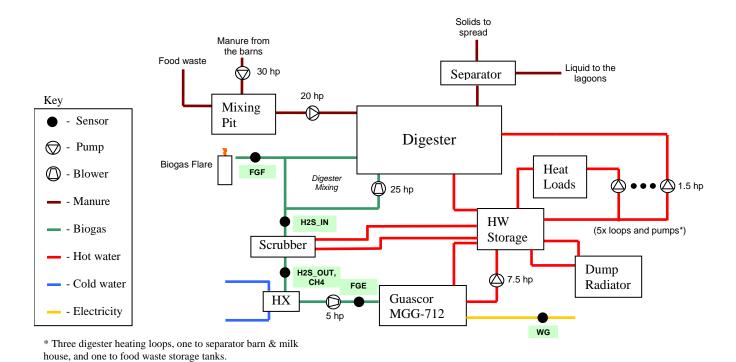
Figure 3. Schematic of ADG System

Figure 3 shows the locations of the three (3) new biogas measurements. The gas analyzer measures H<sub>2</sub>S levels prior to the biological scrubber (**H2S\_IN**), H<sub>2</sub>S levels after the biological scrubber (**H2S\_OUT**). Information on these data points is shown in Table 2.
